# Imagine a Bay State Without Beaches

## Strategies for balancing coastal defense and public access

By Gena Morgis  
Masters of Landscape Architecture Candidate 2021  
Harvard Graduate School of Design  
For E. Bruce Berman, Jr.  
Director of Strategy & Communications  
Save the Harbor/Save the Bay  
August 11, 2020

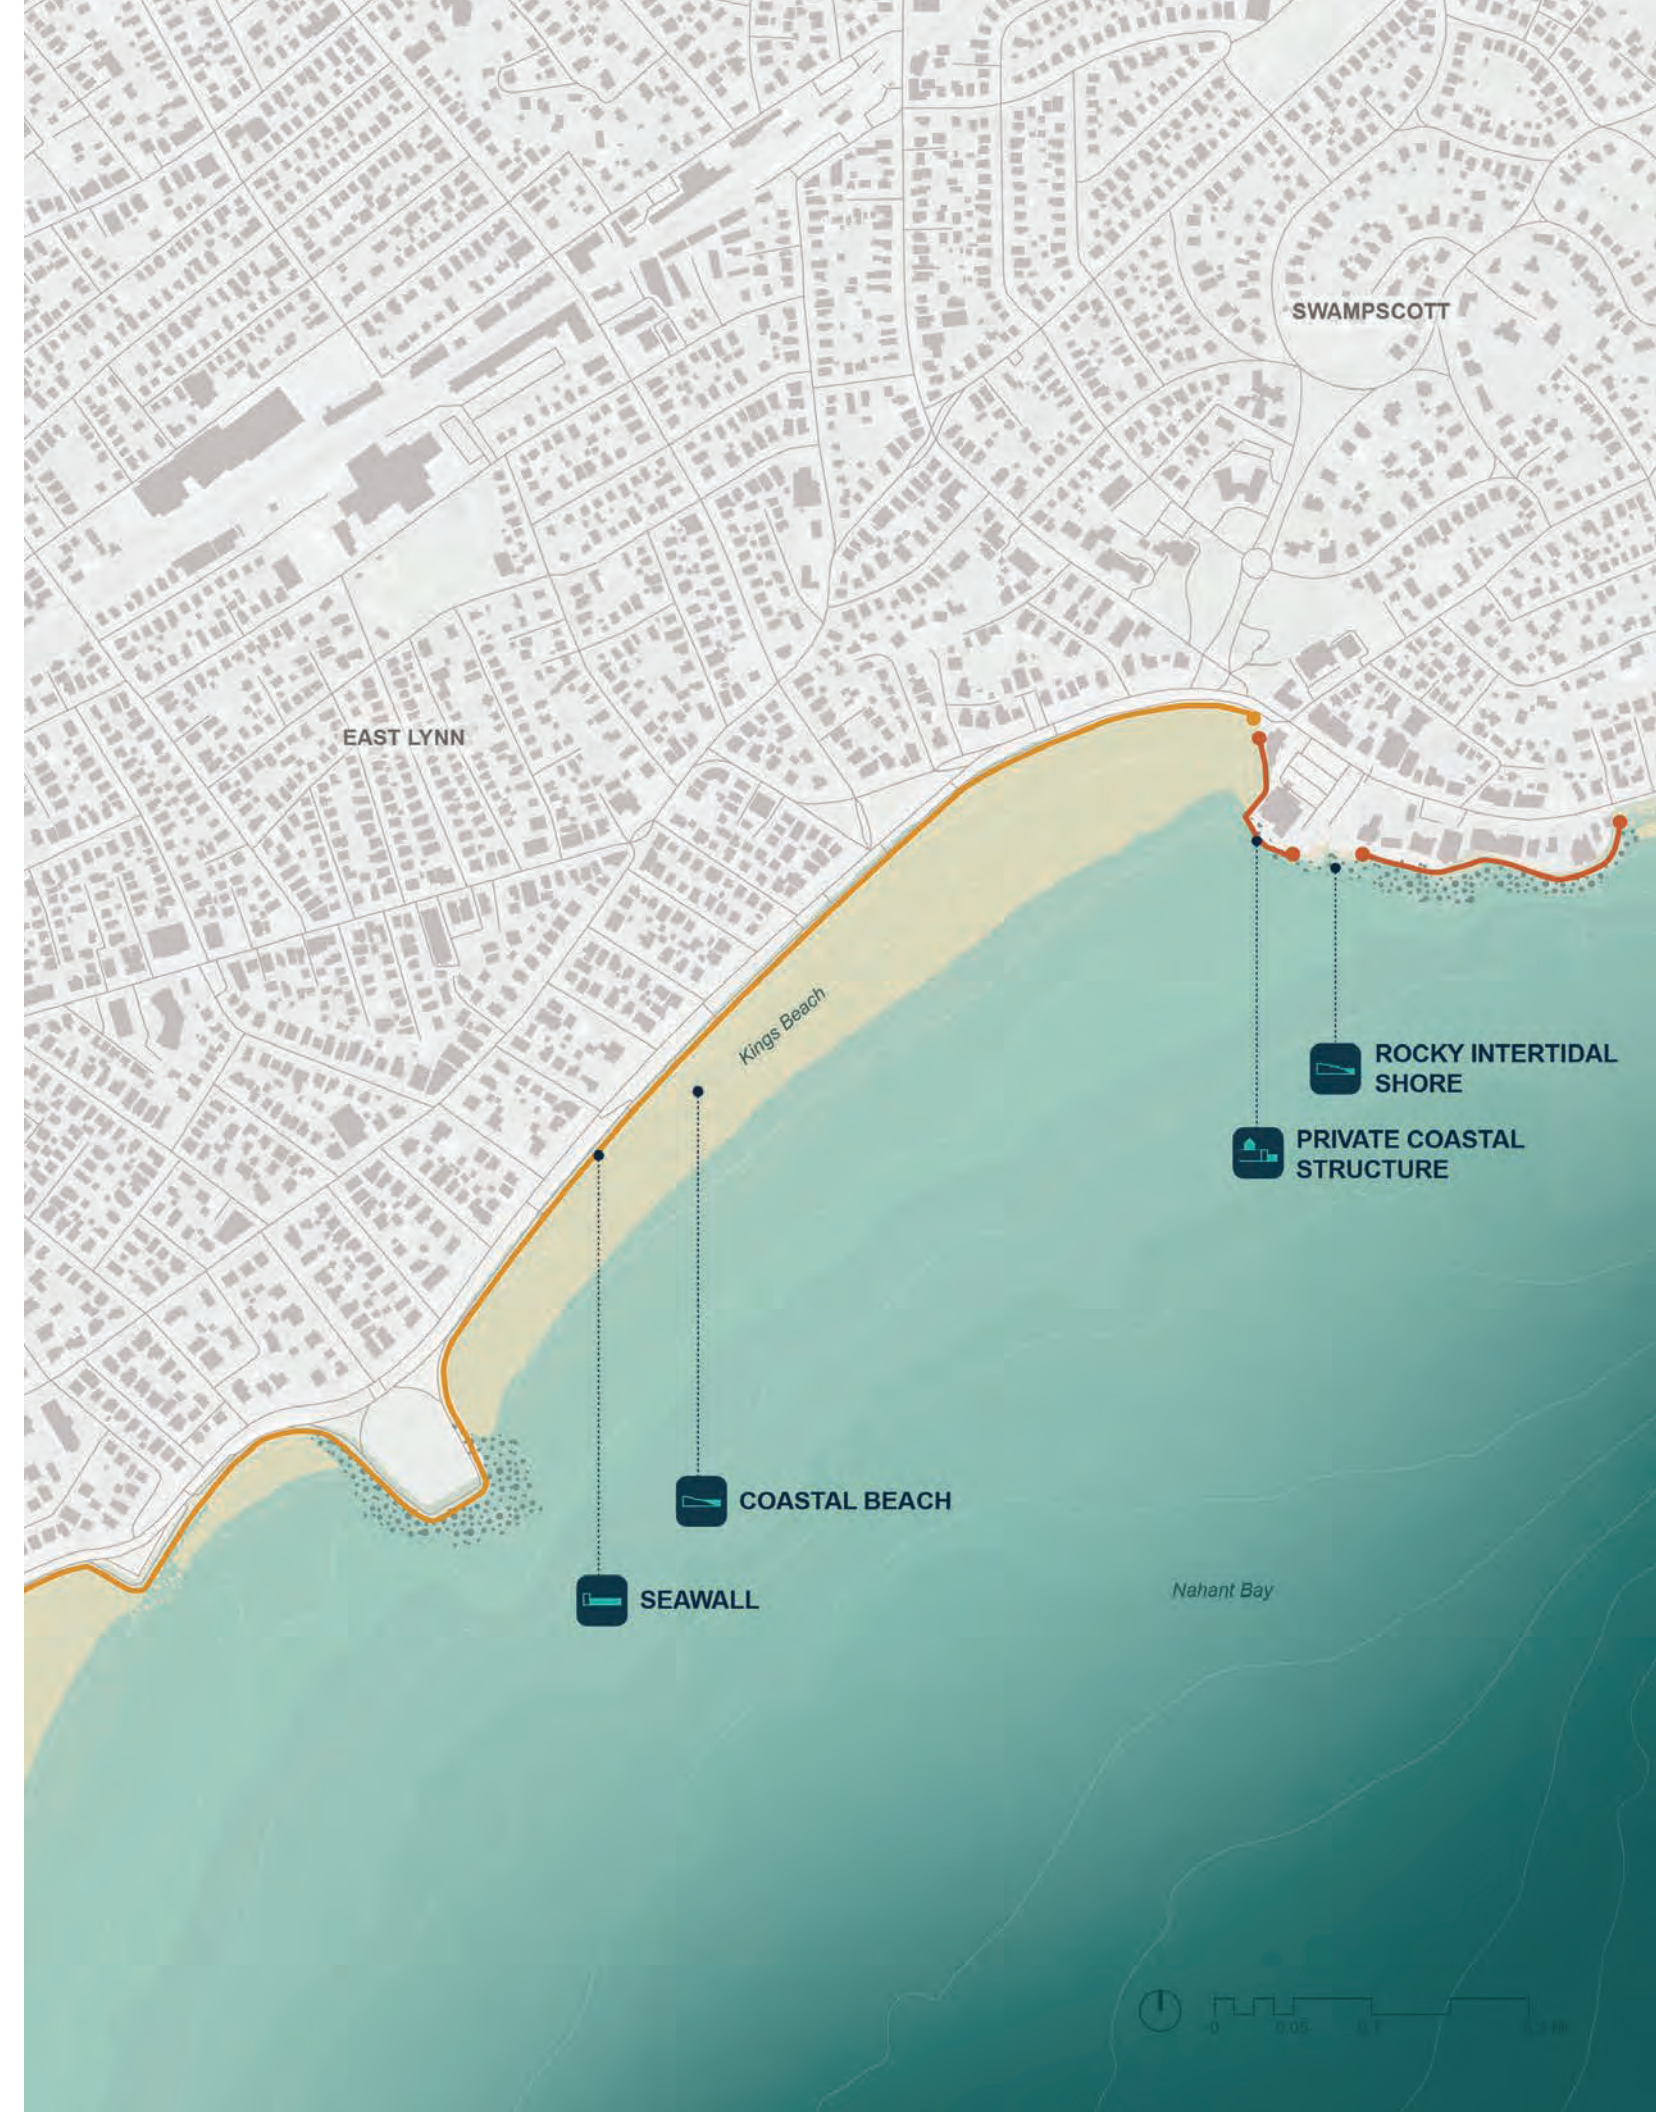
Along Kings Beach, a seawall is the primary defense against coastal flooding. The Nahant Causeway south of the Lynn shoreline also provides an additional buffer from damaging storm waves and flooding. While these physical conditions reduce risk, large storms still have the potential to impact the Lynn community.

areas of observed flooding to produce a more comprehensive dataset. Using GIS data created by the US Army Corps of Engineers, the adjacent map begins to visualize potential extents of hurricane inundation zones dependent on storm severity.

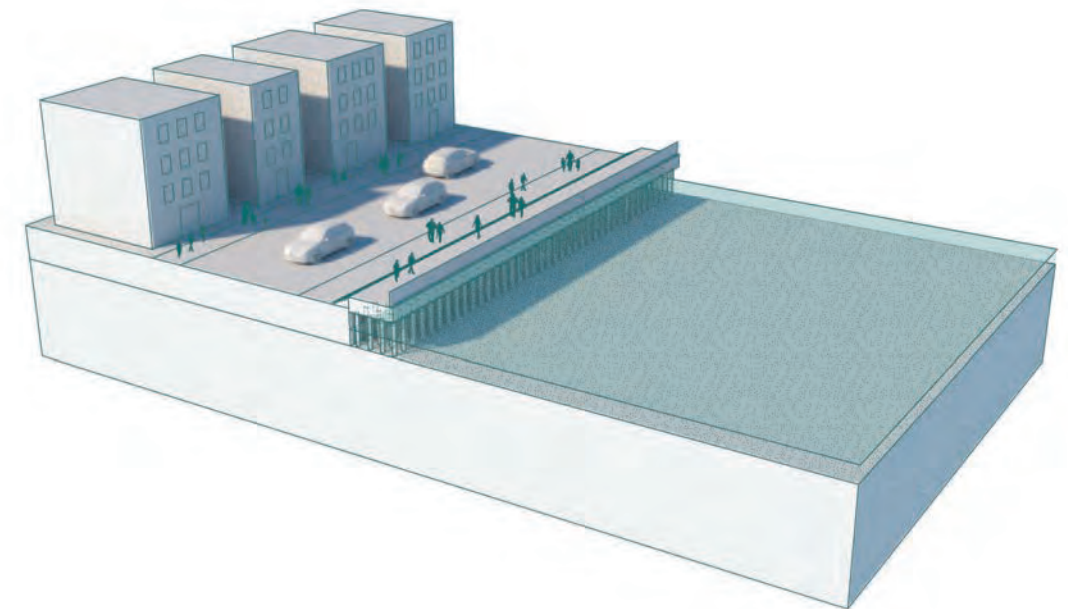
**Extended and Elevated Harborwalk**

The Harborwalk presents opportunities to extend into the harbor and develop a new comprehensive system that incorporates flood mitigation infrastructure. An expanded Harborwalk could introduce new public space while bolstering coastal defenses.

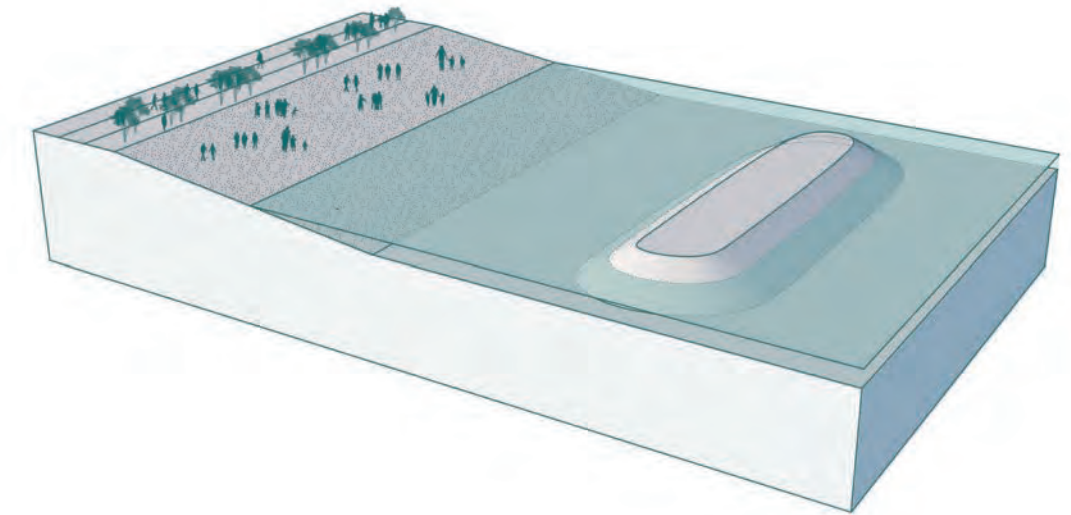
**Barrier Breakwater**

A barrier island condition composed of rip rap material is an infrastructure that can absorb the impact of damaging waves. With this condition, beaches will be sheltered and reduce destruction on developed inland areas.

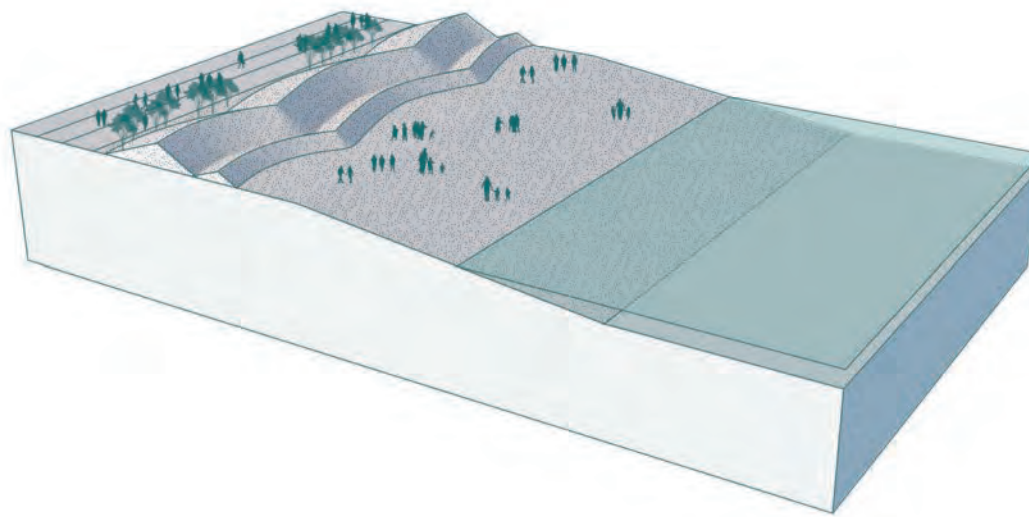
**Layered Dunes**

Here sand would be used to construct a dune landscape to provide additional buffers to developed shoreline edges. This condition would also support robust habitat conditions.

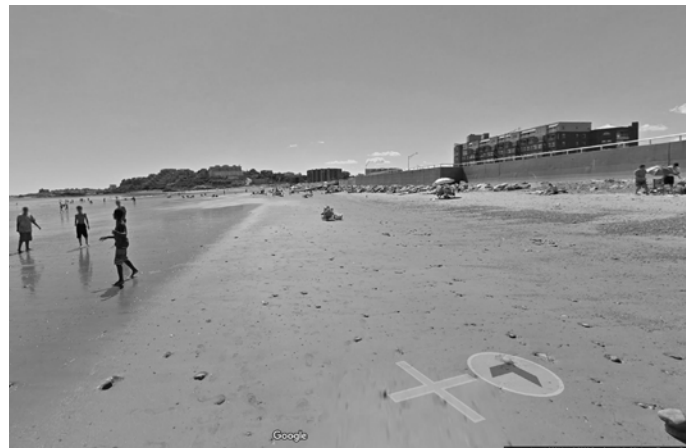
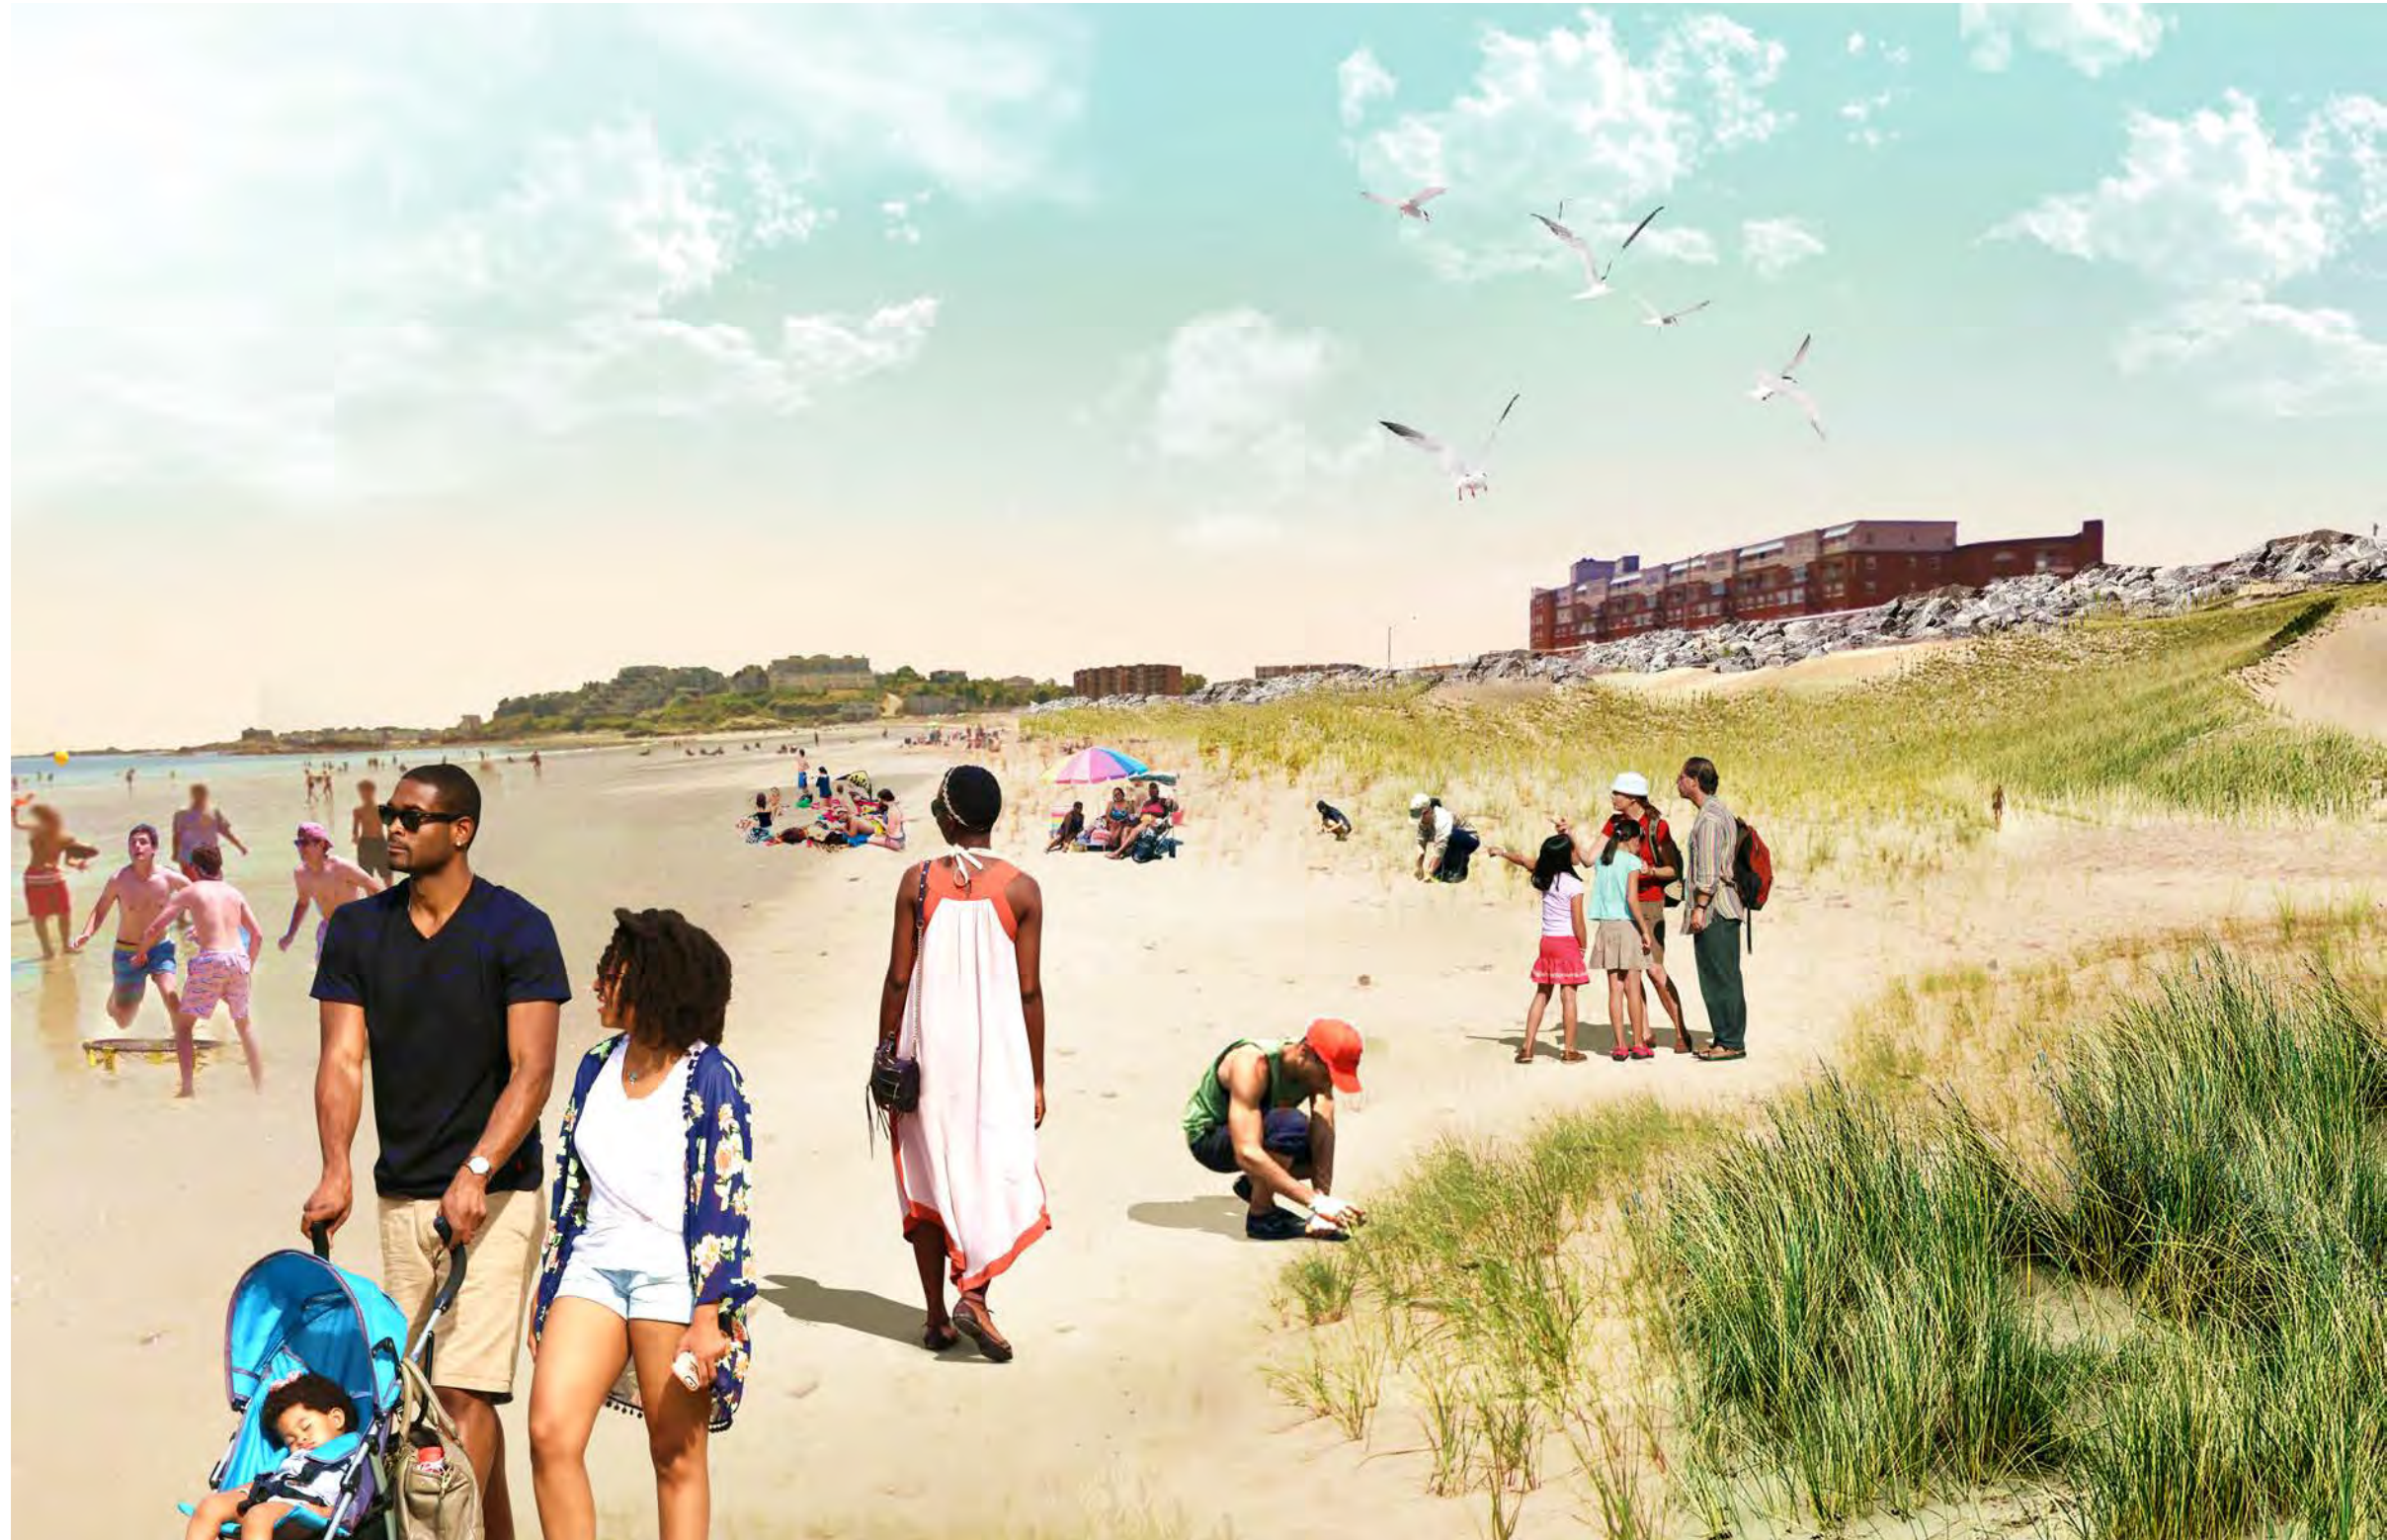
Before Condition:

In a US Army Corps of Engineers document, the viability of maintaining a seawall in this location along Nantasket Beach could potentially result in compromising the shoreline. In the adjacent image, a rendering is used as a tool to begin to imagine the potential infrastructural futures of this section of the beach. Instead of a vertical edge, an inland parking lot area is converted into a revetment supported by a dune system.
